SLOW DOWN

SPEED OBSERVATION STUDY REPORT APRIL 2023

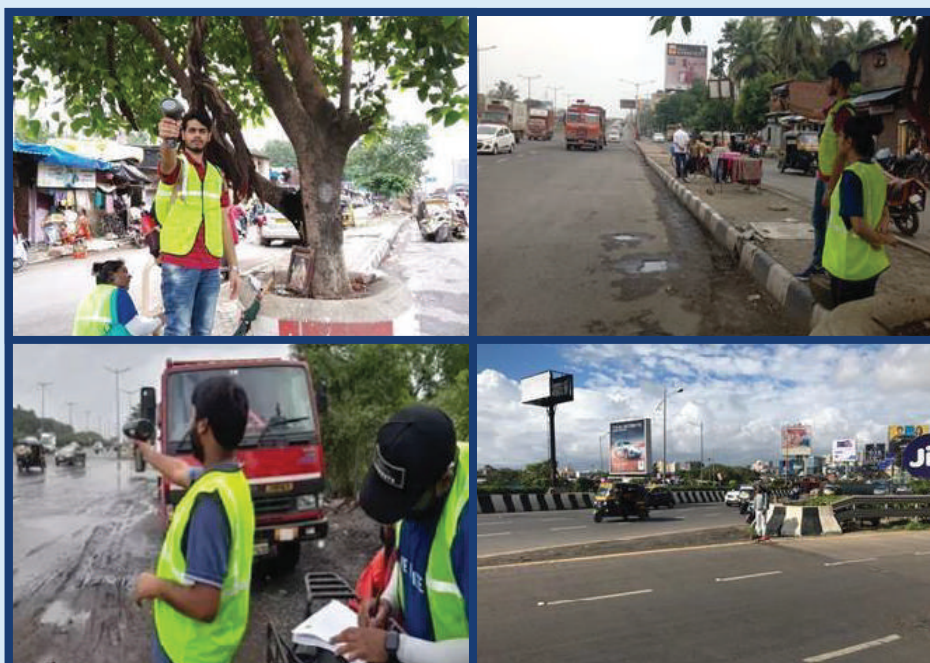
Speed observation study surveys were conducted using radar guns at selected 20 locations for 2 days each (one-week day and one-week end day from 10.30 am to 11.00 pm). Measuring speed using radar uses reflected waves of very high frequency from the radar speed meter to the moving vehicle. The reflected wave is directly measurable and is proportional to the speed at which the vehicle is moving.

The methodology involved in the speed data collection was simple but scientific. During the data collection surveys, a spot was chosen at the black spot location such that a clear view of the oncoming traffic was available, but the enumerator was inconspicuous. If the enumerator holding the radar gun stands out, the drivers tend to slow down, and the free flow speed will not be obtained. During the survey, the enumerator points the radar gun so that the vehicle is either moving directly toward the radar gun or directly away from the gun. The enumerator will then press the trigger and the speed will be displayed on the screen. The speed gun also had a continuous mode which allows the enumerator to detect the speed of the vehicle without having to press the button for each vehicle in case of heavy flow of traffic.

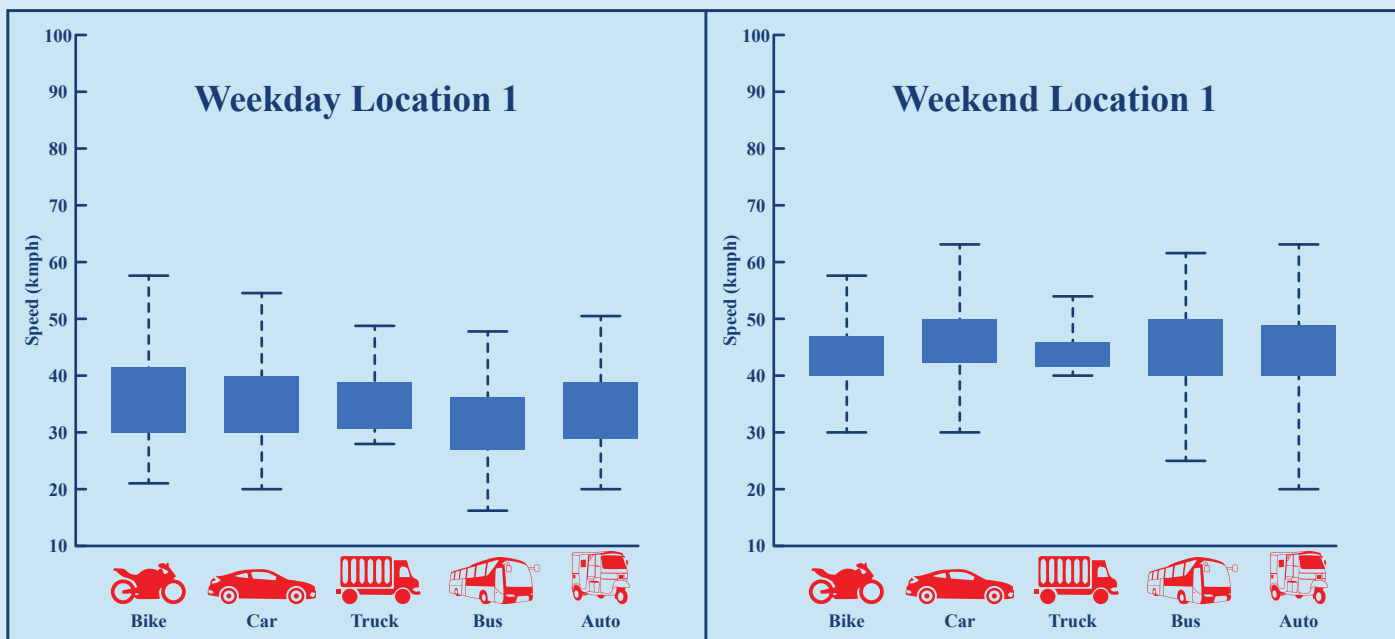
Location: Eastern Express Highway, Near Ramabai Nagar Bus Stop, Near Sainagar Nala, Retiwala, Ghatkopar East

The box contains the middle 50% of the data sample – the bottom and top of the box are the 25th and 75th percentile. The remaining 50% of the sample is contained within the areas between the box and the whiskers. Speed distribution of the motorized two wheelers (bike) is normally distributed because the median line is located near the center of the box and the box is nearly centered between the whiskers.

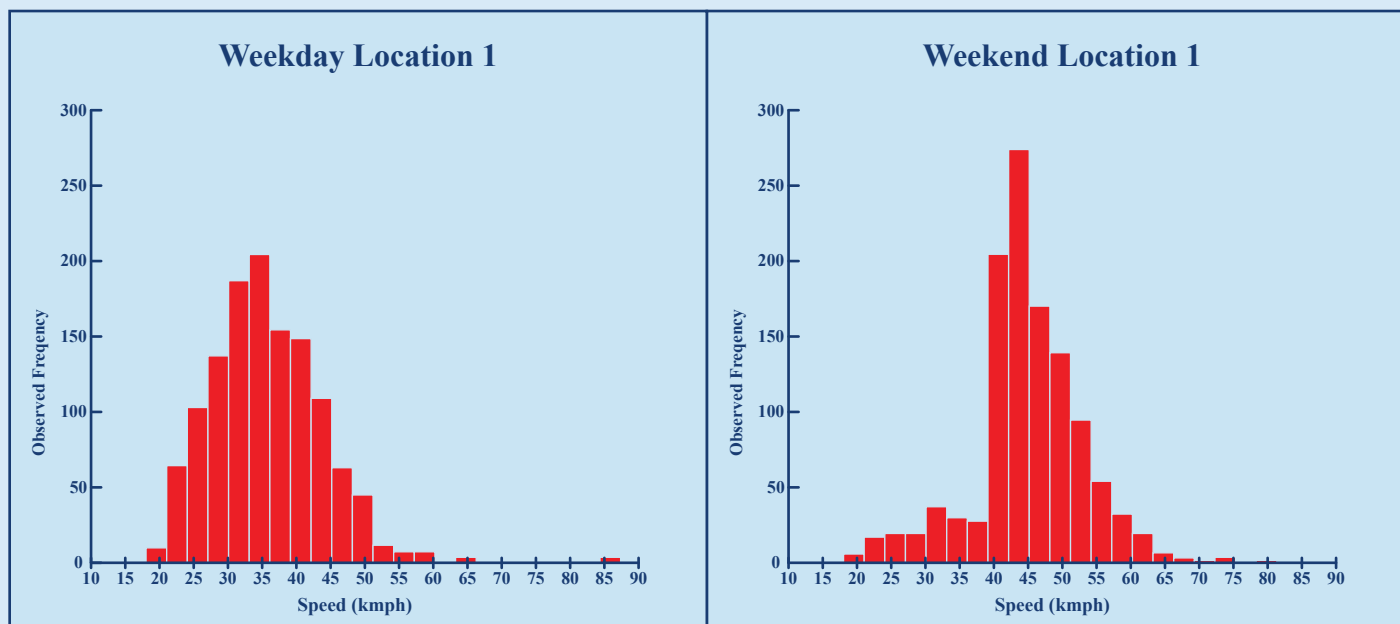
Location: Eastern Express Highway, Near Ramabai Nagar Bus Stop, Near Sainagar Nala, Retiwala, Ghatkopar East

Speed Histogram

It helps to visualize the distribution of the data. Box plots and speed histograms for all 20 locations have been analyzed on both weekdays and weekends.

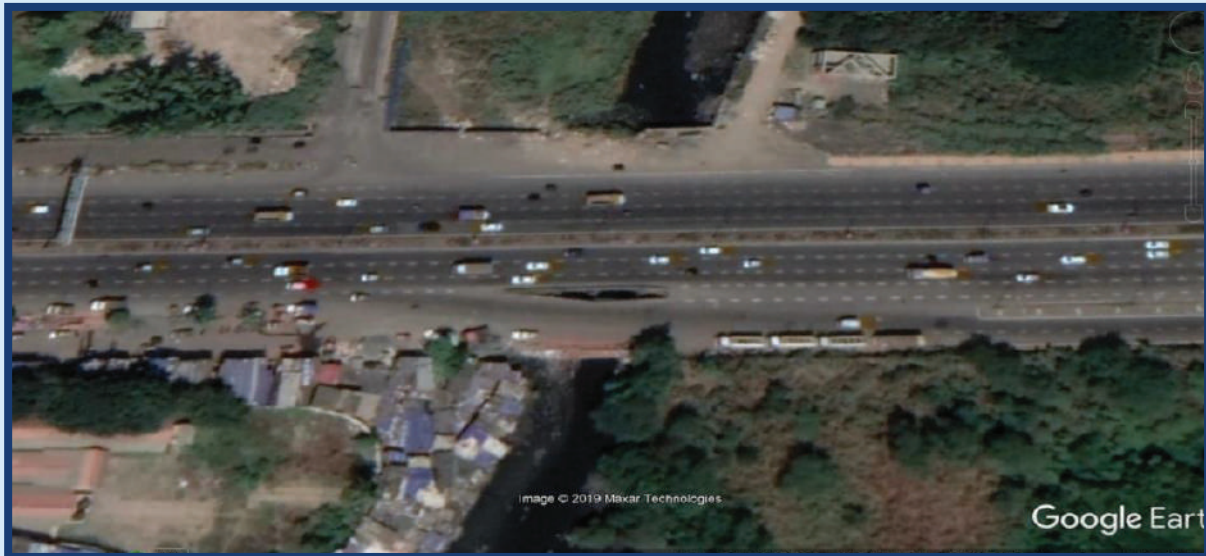
Figure: 1 Google earth view of Eastern Express Highway, Near Ramabai Nagar Bus Stop, Near Sainagar Nala, Retiwala, Ghatkopar East

It is a midblock section with a 10-lane divided carriageway and 2 service lanes on either side. Considered speed limit is 70 kmph.

Infrastructure: Existing rumble strips are not very effective in reducing the high speed of expressway users. No speed limit signs, and merging section ahead sign board. Existing road markings were observed to be faded and some temporary road markings were provided as a part of the Metro construction being carried out at the location.

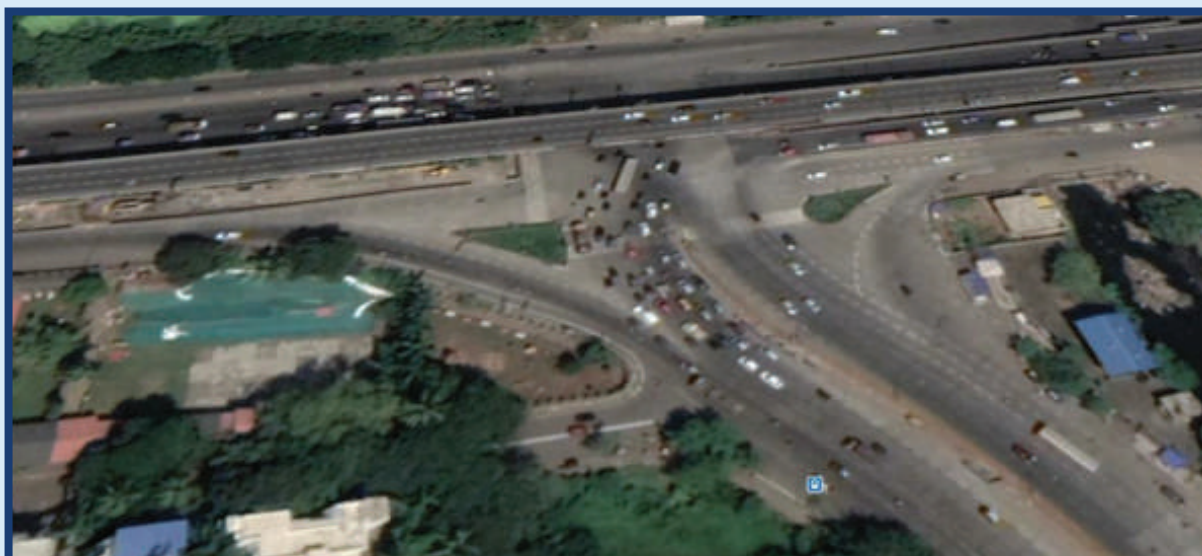
Figure 7: Google earth view of Chheda Nagar & SCLR Bridge Chheda Nagar, Bus Stop, Chembur East

It is a signalized T-intersection with no countdown timer. The carriageway at Chheda Nagar consists of 8 lanes (Ghatkopar - Mankhurd) divided road as shown in Figure 4. Eastern Express Highway is passing over the Chembur junction. Considered speed limit is 50 kmph.

Infrastructure: Traffic signal system is implemented at the junction (Green time of 65 seconds, red time of 85 seconds) without countdown timing in the signal; during peak hours, the traffic was in fully jammed/congested condition starting from the flyover exit. Police were controlling the overall traffic at this junction. Rumble strips were absent on all the approach roads and vehicles were moving at very high speeds during the off-peak time (from the exit of the flyover). Lane markings such as Zebra crossings were faded and the left turning lane marking was absent. Poor visibility at night. Available road width was reduced due to the metro construction work going on both sides.

No speed limit signs, no merging sign board. Improper alignment of the carriageway.

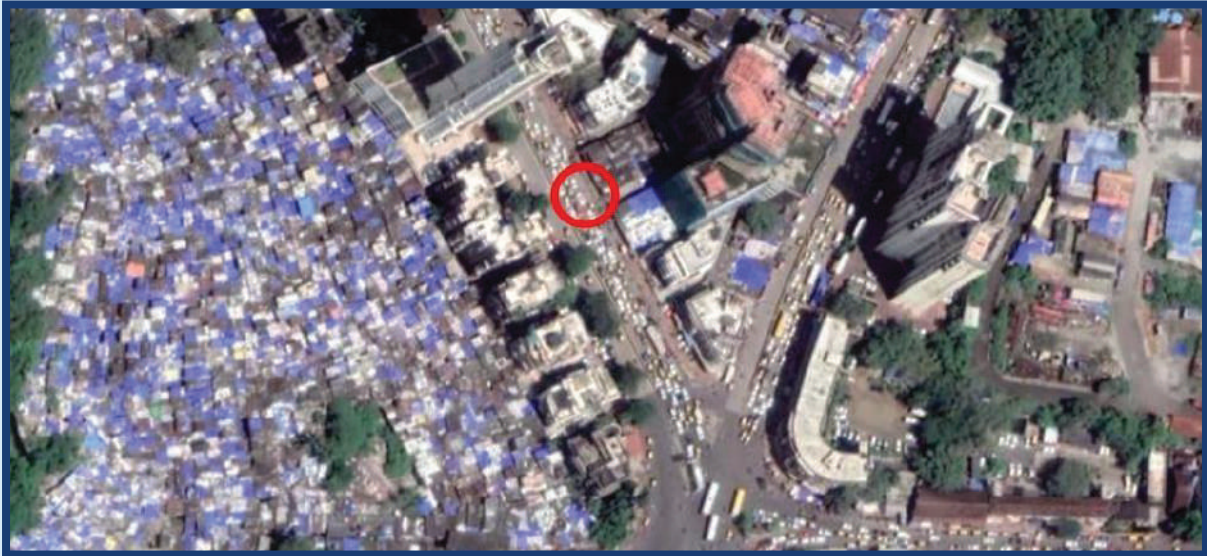
Figure 13: Google earth view of City Bakery, Gafarkhan Bridge, at Worli Naka, Worli

This is a mid-block location with slight side friction. Although the section is between two signalized intersections, the speeds are not very high. Considered speed limit is 50 kmph.

Pedestrian crossing signs and speed limit signs were missing.

Road markings are absent along the stretch and pedestrian crossing markings are absent at the median opening. Pedestrians were observed to randomly cross the road without waiting for the traffic to stop

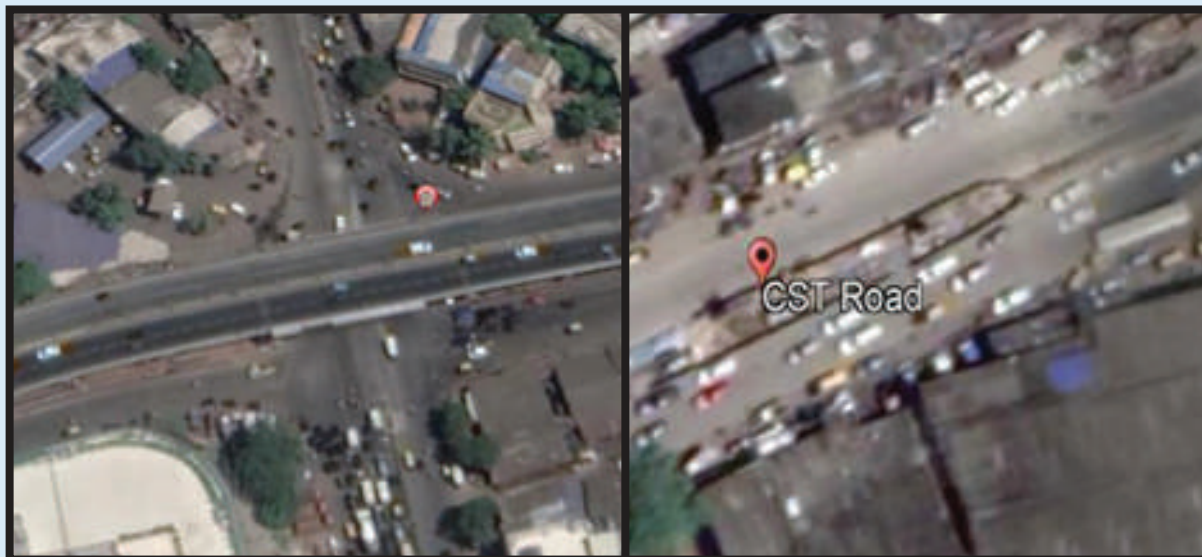
Figure 19: Google earth view of CST Bridge, near Kurla Bus Depot, Kurla West

It is a four-legged signalized intersection. Land use is mixed in nature. The intersection does not have a proper channelizing island and all the roads are 4 lanes (divided) with broken medians. The speed of the vehicles is very less because of the reduction in the width of lanes. A speed limit sign of 20 kmph was present at the location.

Infrastructure: It is a four-legged signalized intersection with no countdown timer. Traffic signal is provided with a green time of 30 seconds for northern, green time of 25 seconds for eastern, green time of 40 seconds for southern and green time of 25 seconds for western. Traffic officials were also observed to be controlling the traffic.

Road markings such as left turn marking, pedestrian crossing markings, etc., were absent and some of them were faded. Available road width was reduced due to the metro construction work being carried out on both sides of the roads. Footpath or sidewalk was observed to be in poor condition. Improper alignment of the carriage way and pavement surface was in poor condition.

Behavioral risk factors: Side friction around the junction was caused due to the parked vehicles. Drivers were observed to be negligent of traffic rules and regulations.

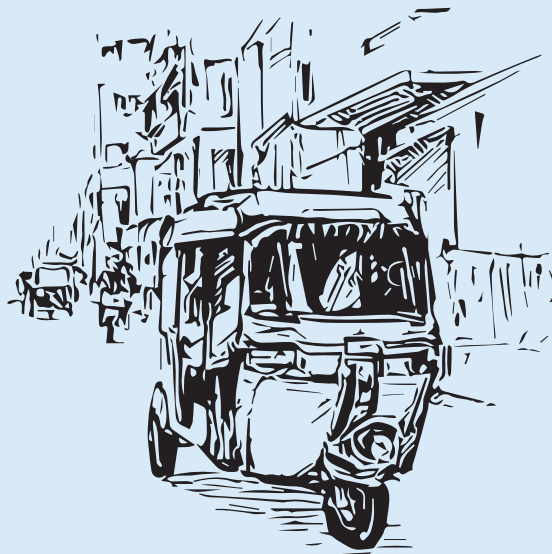
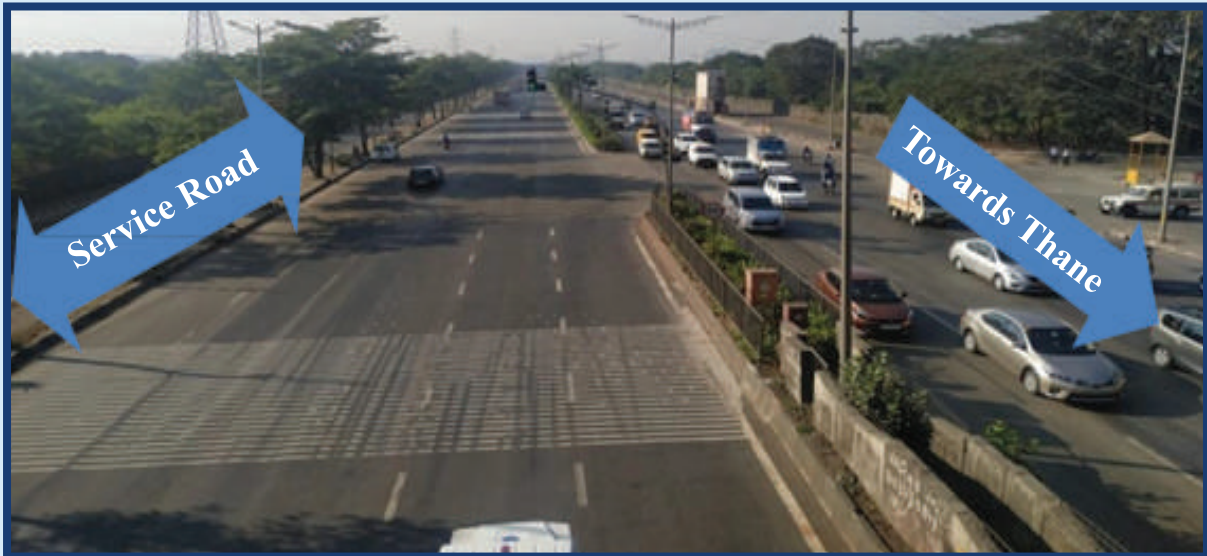
Figure 25: Google earth view and photograph of Godrej Ghodagate Signal, Vikhroli (East)

Godrej Ghodagate Signal, Thane- Mumbai Way, Vikhroli (East). It is three-legged signalized junction with Eastern Express Highway passing through it. The carriageway at Godrej consists of 10 lanes divided. It also has a two-lane service road on either side of junction. Foot over bridge is also present for the smooth movement of pedestrians. Speed limit sign of 60 kmph was present at the location.

Risky merging sections: Buses were sometimes found to stop in the second lane for passenger alighting rather than maneuvering close to the Godrej Soap bus stop posing serious conflict risks. Potential conflict can be caused due to rear end conflicts due to vehicles abruptly slowing down because of the signal.

Infrastructure: Traffic signal system has a countdown timer with a green time of 105 seconds, red time of 27seconds and an amber time of 5 seconds. Rumble strips are provided on the expressway. Lane markings are slightly faded. Road signs were observed to be absent. Inadequate road signs.

Behavioral risk factors: Speed limit sign of 60 kmph was observed at the location, but vehicles could be observed to be travelling at higher speeds on the Expressway. Pedestrians do not use foot over bridge.
